UNDERWATER FACILITIES
INSPECTIONS
AND
ASSESSMENTS
AT

NAVAL COASTAL
SYSTEMS CENTER
PANAMA CITY, FLA.

FPO-I-85-(17)

JUNE 1985

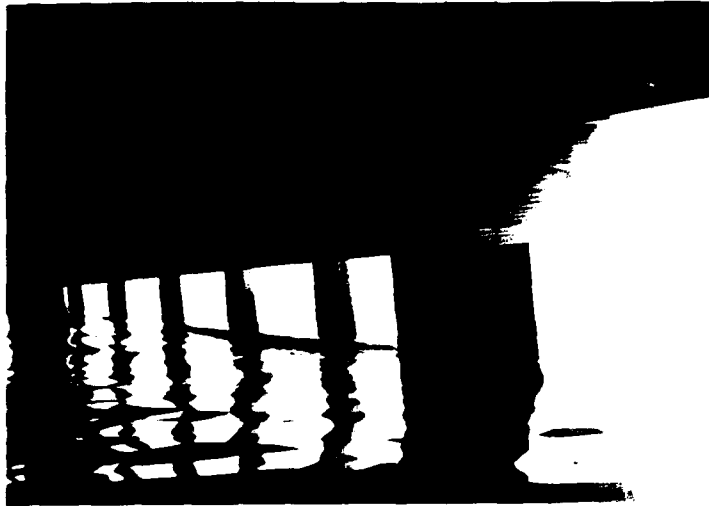
PHOTO 17

Pier 295, showing appearance of substructural connections and framing.

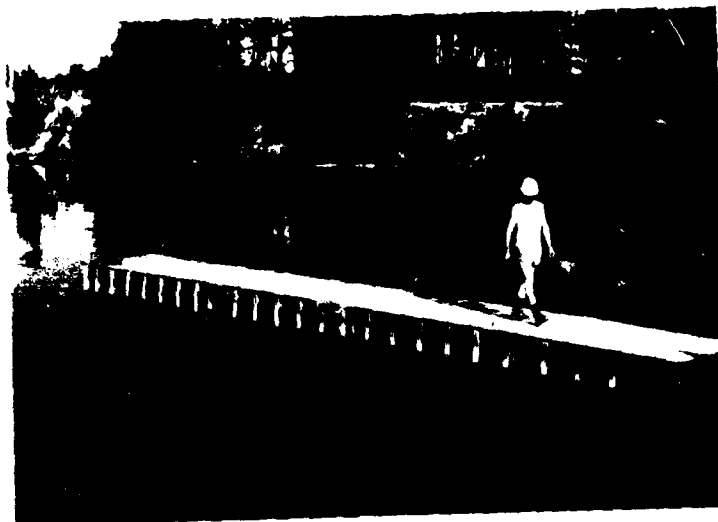
PHOTO 19

Pier 227, showing overall view.

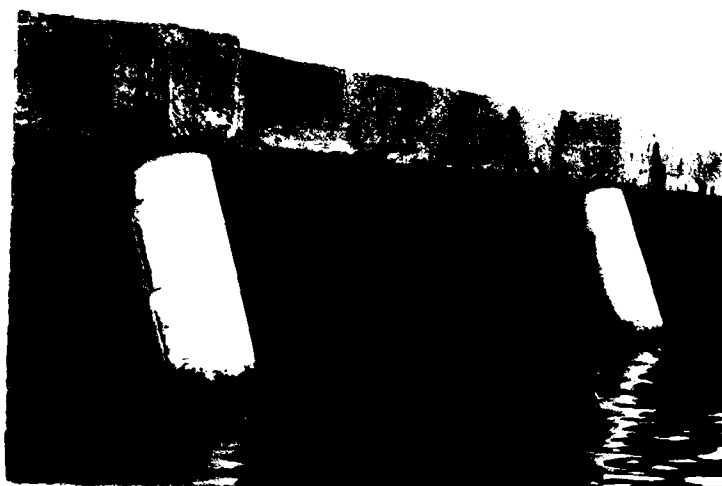
Seawall 171, showing encased lateral support piles.

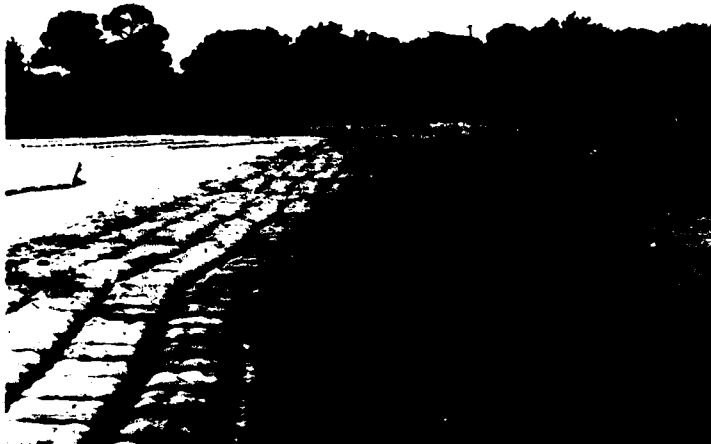
PHOTO 31

Landing Craft Ramp 1, showing well placed concrete
mat riprap.
